PRESERVATION ASSESSMENT AND PLAN FOR SPRINGWOOD CEMETERY, CITY OF GREENVILLE, S.C.

Prepared By:
Michael Trinkley, Ph.D.
and
Debi Hacker

CHICORA RESEARCH CONTRIBUTION 440

March 31, 2006

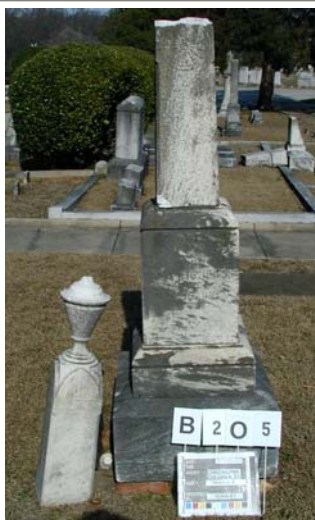
Position: ☒ fallen ☐ unstable ☐ tilted ☒ unattached/loose ☐ missing ☐ shifted

Deterioration: ☒ broken ☐ cracked ☐ losses ☐ flaking/sugaring ☐ ferrous pins
☐ delamination/detachment ☐ missing fragments ☐ other:

Soiling: ☒ biological ☐ staining ☐ efflorescence ☐ other:

Position: ☐ reset in ground ☒ reset/level to existing base ☐ construct new base
☐ possible new base required ☐ stabilize foundation ☐ resquare

Treatment: ☐ core drill ☒ drill and pin ☐ adhesive repair ☒ infill w/Jahn or U.S. Heritage
☐ injection grout ☐ replace bricks ☐ mortar ☐ repoint ☐ other:

Cost: \$800

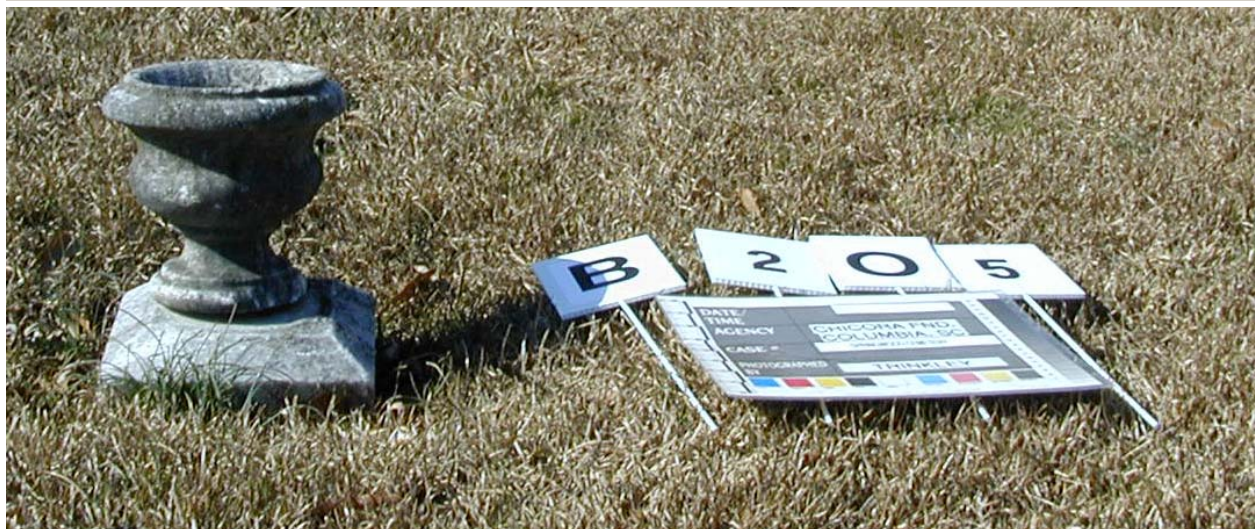
Section: B

Position: ☐ fallen ☐ unstable ☐ tilted ☒ unattached/loose ☐ missing ☐ shifted

Soiling: ☒ biological ☐ staining ☐ efflorescence ☐ other:

Treatment: ☐ core drill ☒ drill and pin ☐ adhesive repair ☐ infill w/Jahn or U.S. Heritage
☐ injection grout ☐ replace bricks ☐ mortar ☐ repoint ☐ other:

Cost: \$150

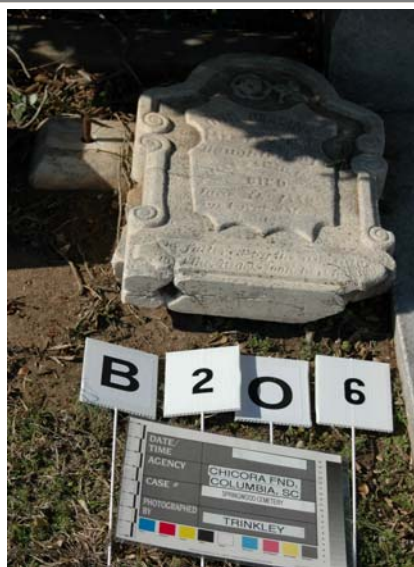
Position: ☒ fallen ☐ unstable ☐ tilted ☒ unattached/loose ☐ missing ☐ shifted

Deterioration: ☒ broken ☒ cracked ☐ losses ☐ flaking/sugaring ☒ ferrous pins
☐ delamination/detachment ☒ missing fragments ☐ other:

Soiling: ☒ biological ☐ staining ☐ efflorescence ☐ other:

Position: ☐ reset in ground ☒ reset/level to existing base ☐ construct new base
☐ possible new base required ☐ stabilize foundation ☐ resquare

Treatment: ☒ core drill ☒ drill and pin ☐ adhesive repair ☒ infill w/Jahn or U.S. Heritage
☐ injection grout ☐ replace bricks ☐ mortar ☐ repoint ☐ other:

Cost: \$750

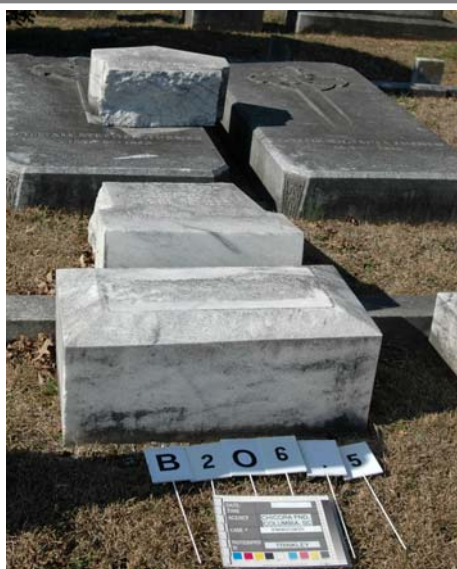
Position: ☒ fallen ☐ unstable ☐ tilted ☒ unattached/loose ☐ missing ☐ shifted

Deterioration: ☒ broken ☐ cracked ☐ losses ☐ flaking/sugaring ☐ ferrous pins
☐ delamination/detachment ☐ missing fragments ☐ other:

Position: ☐ reset in ground ☒ reset/level to existing base ☐ construct new base
☐ possible new base required ☐ stabilize foundation ☐ resquare

Treatment: ☐ core drill ☐ drill and pin ☒ adhesive repair ☒ infill w/Jahn or U.S. Heritage
☐ injection grout ☐ replace bricks ☐ mortar ☐ repoint ☐ other:

Cost: \$300

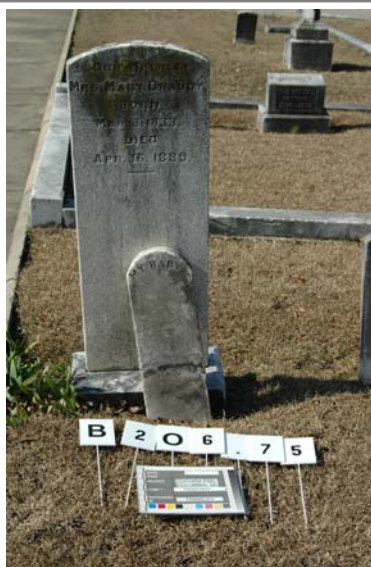
Position: ☒ fallen ☐ unstable ☐ tilted ☒ unattached/loose ☐ missing ☐ shifted

Soiling: ☒ biological ☐ staining ☐ efflorescence ☐ other:

Position: ☒ reset in ground ☐ reset/level to existing base ☐ construct new base
☐ possible new base required ☐ stabilize foundation ☐ resquare

Cost: \$90

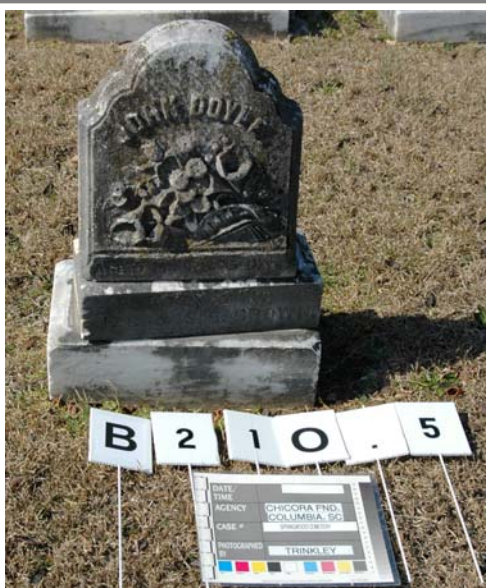
Position: ☐ fallen ☐ unstable ☐ tilted ☒ unattached/loose ☐ missing ☒ shifted

Deterioration: ☐ broken ☐ cracked ☐ losses ☐ flaking/sugaring ☒ ferrous pins
☐ delamination/detachment ☐ missing fragments ☐ other:

Soiling: ☒ biological ☐ staining ☐ efflorescence ☐ other:

Position: ☐ reset in ground ☒ reset/level to existing base ☐ construct new base
☐ possible new base required ☐ stabilize foundation ☐ resquare

Treatment: ☒ core drill ☒ drill and pin ☐ adhesive repair ☐ infill w/Jahn or U.S. Heritage
☐ injection grout ☐ replace bricks ☐ mortar ☐ repoint ☐ other:

Cost: \$500

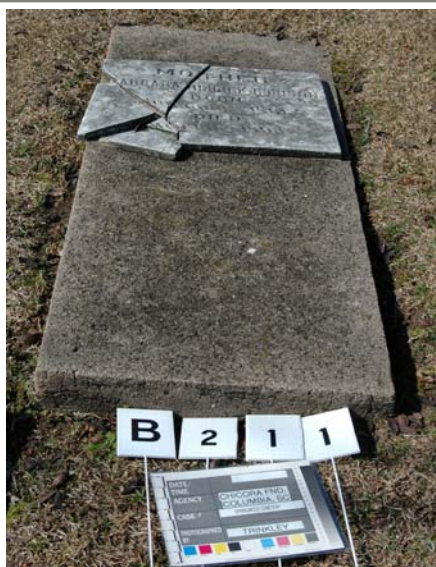
Position: ☐ fallen ☐ unstable ☒ tilted ☒ unattached/loose ☐ missing ☐ shifted

Deterioration: ☒ broken ☐ cracked ☐ losses ☐ flaking/sugaring ☐ ferrous pins
☐ delamination/detachment ☐ missing fragments ☐ other:

Position: ☐ reset in ground ☐ reset/level to existing base ☐ construct new base
☐ possible new base required ☒ stabilize foundation ☐ resquare

Treatment: ☐ core drill ☐ drill and pin ☒ adhesive repair ☒ infill w/Jahn or U.S. Heritage
☐ injection grout ☐ replace bricks ☐ mortar ☐ repoint ☐ other:

Cost: \$450

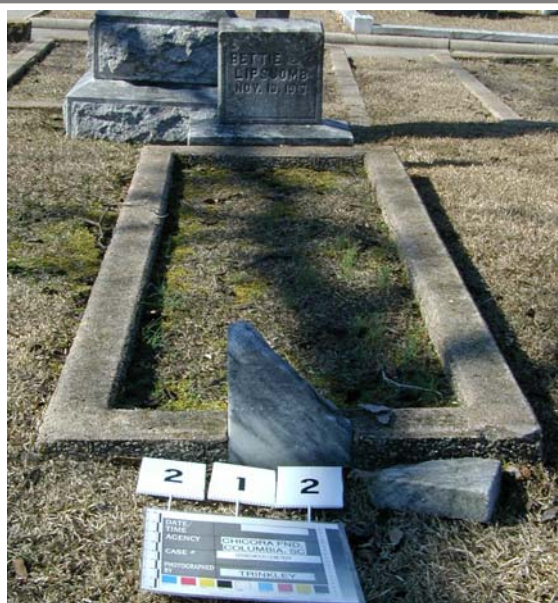
Position: ☐ fallen ☐ unstable ☐ tilted ☒ unattached/loose ☐ missing ☐ shifted

Deterioration: ☒ broken ☐ cracked ☐ losses ☐ flaking/sugaring ☐ ferrous pins
☐ delamination/detachment ☐ missing fragments ☒ other: footstone only

Treatment: ☐ core drill ☐ drill and pin ☒ adhesive repair ☒ infill w/Jahn or U.S. Heritage
☐ injection grout ☐ replace bricks ☐ mortar ☐ repoint ☐ other:

Cost: \$150

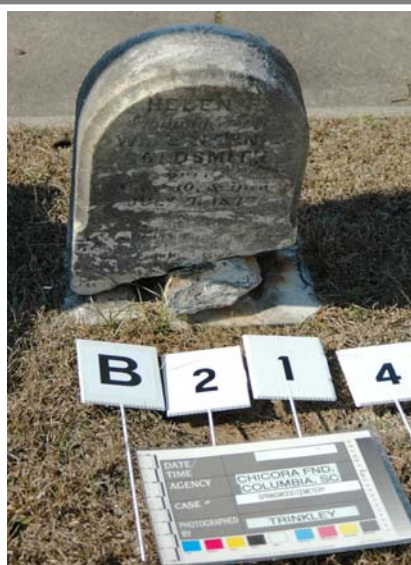
Position: ☐ fallen ☐ unstable ☐ tilted ☒ unattached/loose ☐ missing ☐ shifted

Deterioration: ☒ broken ☐ cracked ☒ losses ☐ flaking/sugaring ☒ ferrous pins
☐ delamination/detachment ☒ missing fragments ☐ other:

Soiling: ☒ biological ☐ staining ☐ efflorescence ☐ other:

Position: ☐ reset in ground ☒ reset/level to existing base ☐ construct new base
☐ possible new base required ☐ stabilize foundation ☐ resquare

Treatment: ☒ core drill ☒ drill and pin ☐ adhesive repair ☒ infill w/Jahn or U.S. Heritage
☐ injection grout ☐ replace bricks ☐ mortar ☐ repoint ☐ other:

Cost: \$600

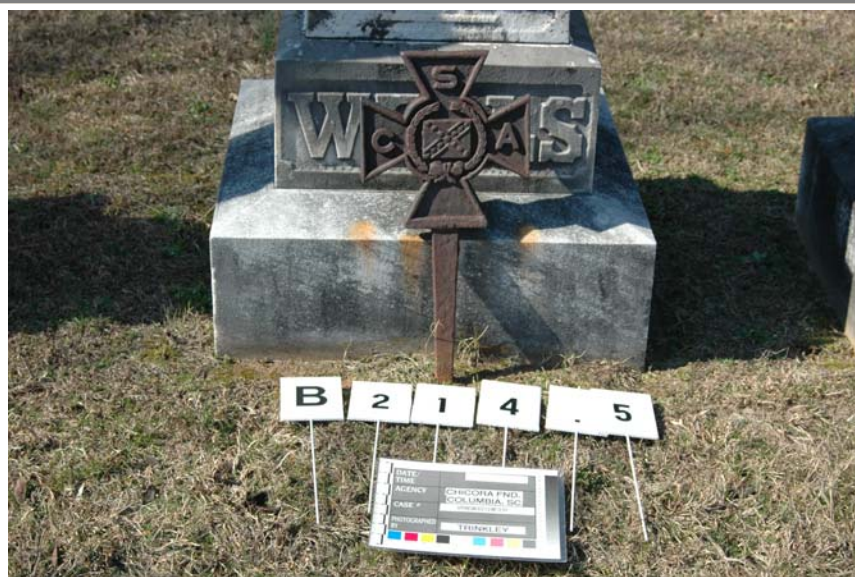
Soiling: ☐ biological ☒ staining ☐ efflorescence ☐ other:

Cost: \$150

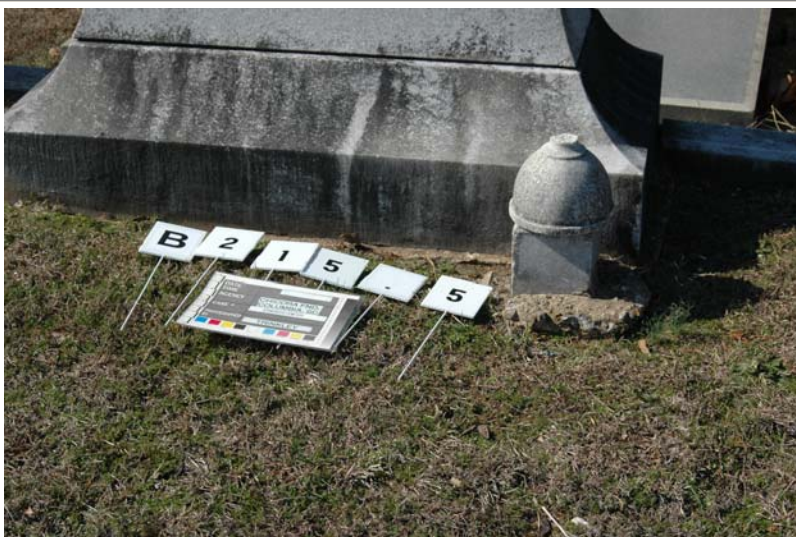
Position: ☐ fallen ☐ unstable ☐ tilted ☒ unattached/loose ☐ missing ☐ shifted

Deterioration: ☒ broken ☐ cracked ☐ losses ☐ flaking/sugaring ☐ ferrous pins
☐ delamination/detachment ☐ missing fragments ☐ other:

Position: ☐ reset in ground ☒ reset/level to existing base ☐ construct new base
☐ possible new base required ☐ stabilize foundation ☐ resquare

Treatment: ☐ core drill ☒ drill and pin ☐ adhesive repair ☒ infill w/Jahn or U.S. Heritage
☐ injection grout ☐ replace bricks ☐ mortar ☐ repoint ☐ other:

Cost: \$150

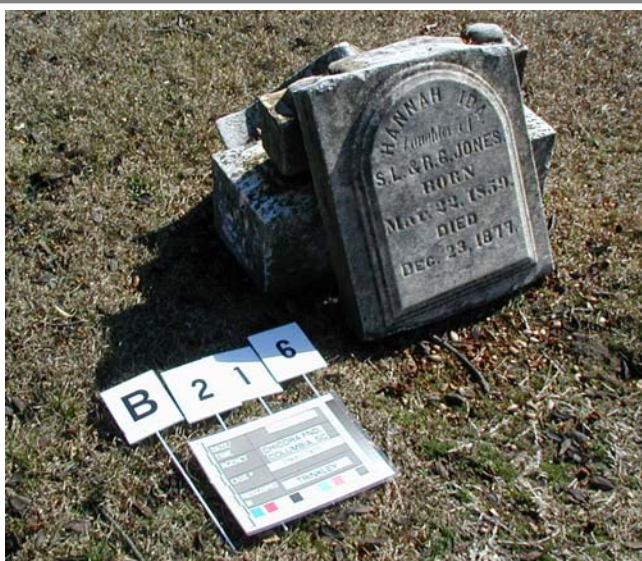
Section: B

Position: ☒ fallen ☒ unstable ☐ tilted ☒ unattached/loose ☐ missing ☐ shifted

Deterioration: ☒ broken ☐ cracked ☐ losses ☐ flaking/sugaring ☐ ferrous pins
☐ delamination/detachment ☐ missing fragments ☐ other:

Soiling: ☒ biological ☐ staining ☐ efflorescence ☐ other:

Position: ☐ reset in ground ☒ reset/level to existing base ☐ construct new base
☐ possible new base required ☐ stabilize foundation ☐ resquare

Cost: \$800

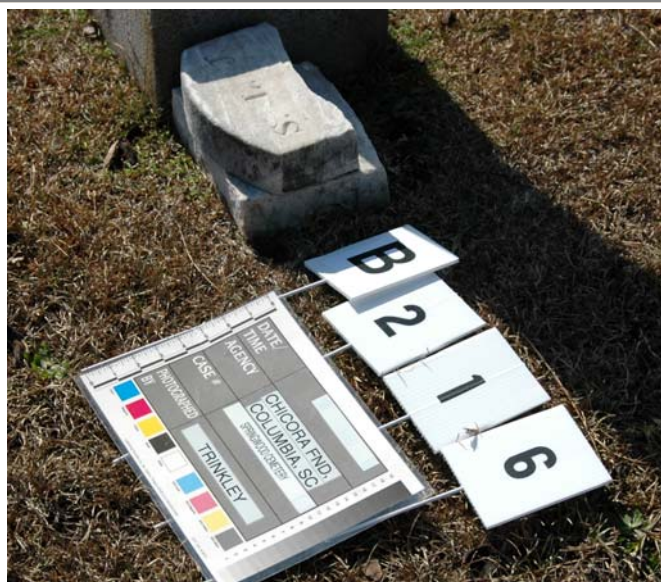
Position: ☐ fallen ☐ unstable ☐ tilted ☒ unattached/loose ☐ missing ☐ shifted

Cost: \$300

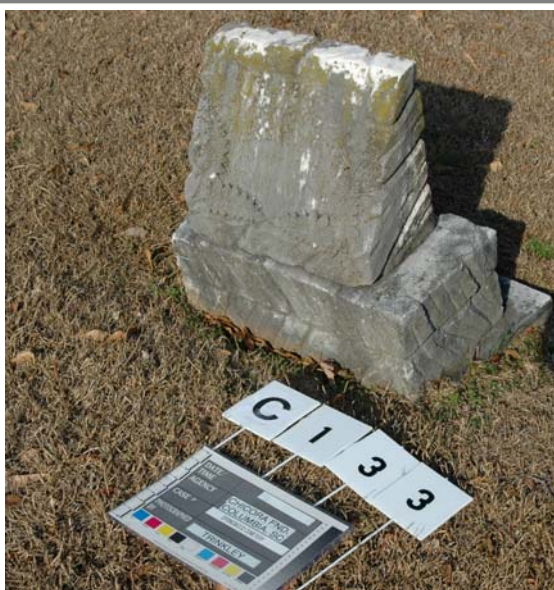
Position: ☒ fallen ☐ unstable ☐ tilted ☐ unattached/loose ☐ missing ☐ shifted

Deterioration: ☒ broken ☐ cracked ☐ losses ☐ flaking/sugaring ☐ ferrous pins
☐ delamination/detachment ☐ missing fragments ☒ other: socket only

Soiling: ☒ biological ☐ staining ☐ efflorescence ☐ other:

Position: ☐ reset in ground ☒ reset/level to existing base ☐ construct new base
☐ possible new base required ☐ stabilize foundation ☐ resquare

Treatment: ☐ core drill ☒ drill and pin ☒ adhesive repair ☐ infill w/Jahn or U.S. Heritage
☐ injection grout ☐ replace bricks ☒ mortar ☐ repoint ☐ other:

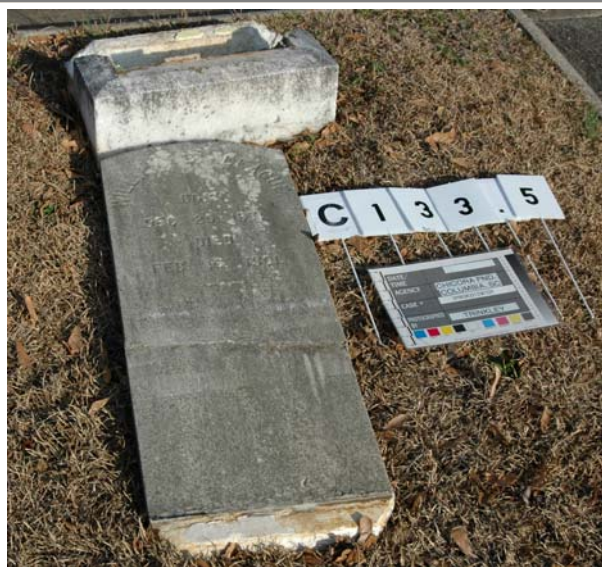
Position: ☒ fallen ☐ unstable ☐ tilted ☒ unattached/loose ☐ missing ☐ shifted

Deterioration: ☒ broken ☐ cracked ☐ losses ☐ flaking/sugaring ☐ ferrous pins
☐ delamination/detachment ☒ missing fragments ☒ other: stone & socket broken; lower 1/2 missing

Soiling: ☒ biological ☐ staining ☐ efflorescence ☐ other:

Position: ☐ reset in ground ☐ reset/level to existing base ☒ construct new base
☐ possible new base required ☐ stabilize foundation ☐ resquare

Treatment: ☐ core drill ☐ drill and pin ☐ adhesive repair ☐ infill w/Jahn or U.S. Heritage
☐ injection grout ☐ replace bricks ☒ mortar ☐ repoint ☒ other: bury socket

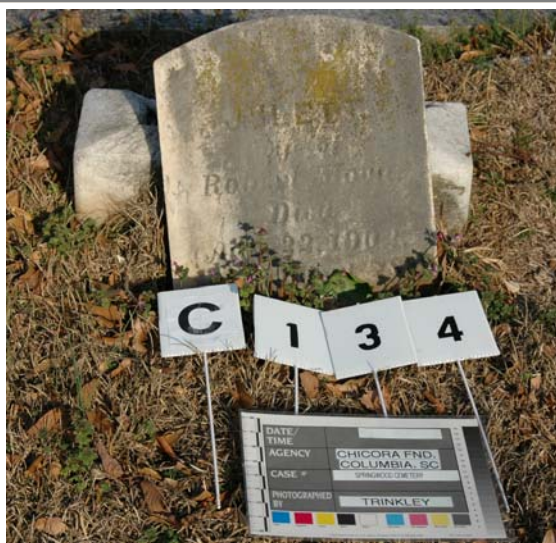
Position: ☒ fallen ☐ unstable ☐ tilted ☐ unattached/loose ☐ missing ☐ shifted

Deterioration: ☒ broken ☐ cracked ☐ losses ☐ flaking/sugaring ☐ ferrous pins
☐ delamination/detachment ☐ missing fragments ☐ other:

Soiling: ☒ biological ☐ staining ☐ efflorescence ☐ other:

Position: ☐ reset in ground ☒ reset/level to existing base ☐ construct new base
☐ possible new base required ☐ stabilize foundation ☐ resquare

Treatment: ☐ core drill ☒ drill and pin ☐ adhesive repair ☒ infill w/Jahn or U.S. Heritage
☐ injection grout ☐ replace bricks ☐ mortar ☐ repoint ☐ other:

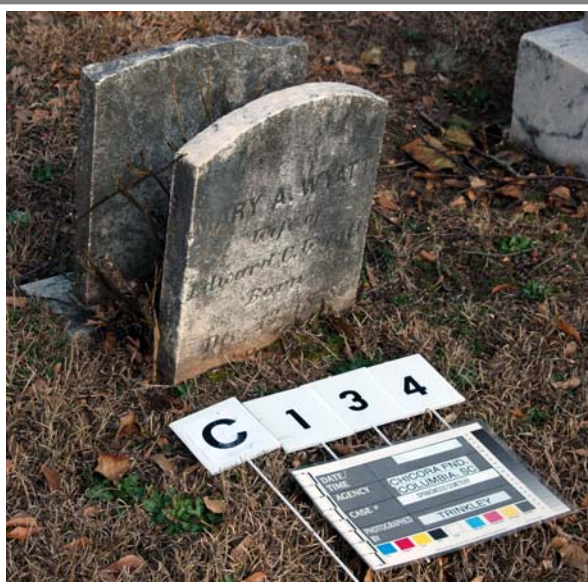
Position: ☐ fallen ☒ unstable ☐ tilted ☒ unattached/loose ☐ missing ☒ shifted

Soiling: ☒ biological ☐ staining ☐ efflorescence ☐ other:

Position: ☐ reset in ground ☒ reset/level to existing base ☐ construct new base
☐ possible new base required ☐ stabilize foundation ☐ resquare

Treatment: ☐ core drill ☒ drill and pin ☐ adhesive repair ☐ infill w/Jahn or U.S. Heritage
☐ injection grout ☐ replace bricks ☐ mortar ☐ repoint ☐ other:

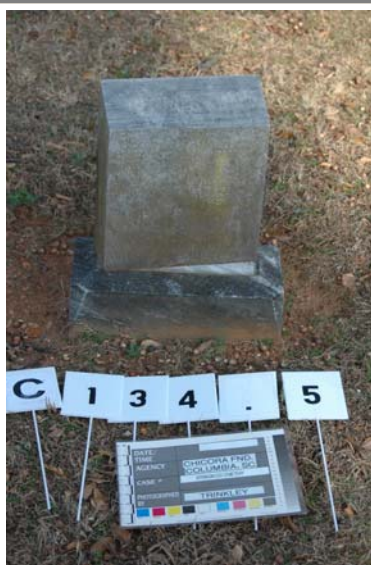
Position: ☐ fallen ☐ unstable ☐ tilted ☒ unattached/loose ☐ missing ☐ shifted

Deterioration: ☒ broken ☐ cracked ☐ losses ☐ flaking/sugaring ☐ ferrous pins
☐ delamination/detachment ☐ missing fragments ☒ other: urn only

Soiling: ☒ biological ☐ staining ☐ efflorescence ☐ other:

Treatment: ☐ core drill ☒ drill and pin ☐ adhesive repair ☐ infill w/Jahn or U.S. Heritage
☐ injection grout ☐ replace bricks ☐ mortar ☐ repoint ☐ other:

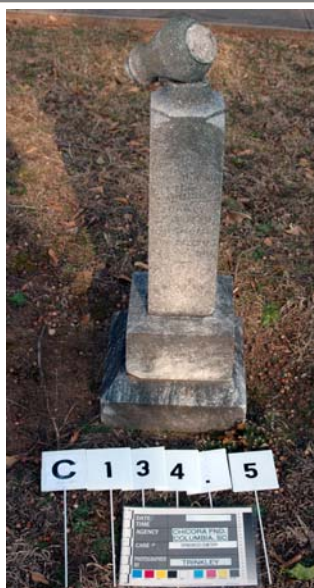
Position: ☐ fallen ☐ unstable ☐ tilted ☒ unattached/loose ☐ missing ☐ shifted

Soiling: ☒ biological ☐ staining ☐ efflorescence ☐ other:

Position: ☐ reset in ground ☒ reset/level to existing base ☐ construct new base
☐ possible new base required ☐ stabilize foundation ☐ resquare

Treatment: ☐ core drill ☒ drill and pin ☐ adhesive repair ☐ infill w/Jahn or U.S. Heritage
☐ injection grout ☐ replace bricks ☐ mortar ☐ repoint ☐ other:

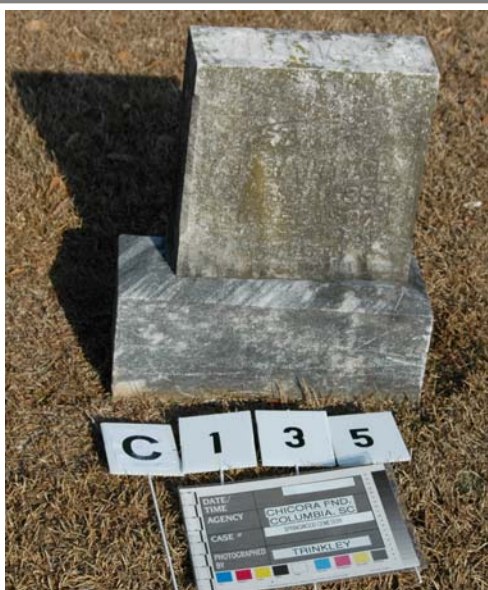
Position: ☒ fallen ☐ unstable ☐ tilted ☒ unattached/loose ☐ missing ☐ shifted

Soiling: ☒ biological ☐ staining ☐ efflorescence ☐ other:

Position: ☒ reset in ground ☐ reset/level to existing base ☐ construct new base
☐ possible new base required ☐ stabilize foundation ☐ resquare

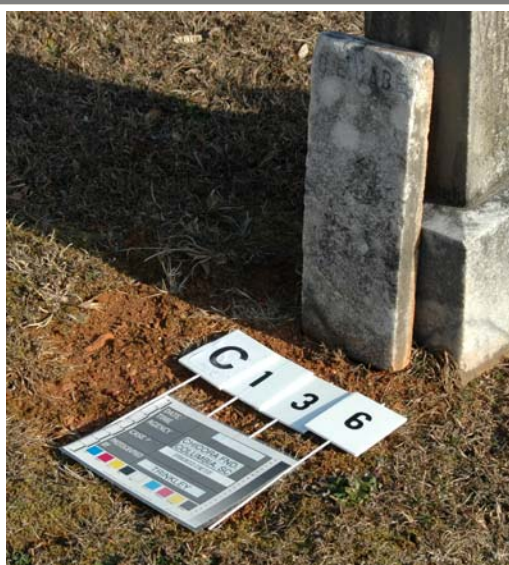
Position: ☐ fallen ☐ unstable ☒ tilted ☒ unattached/loose ☐ missing ☒ shifted

Soiling: ☒ biological ☐ staining ☐ efflorescence ☐ other:

Position: ☐ reset in ground ☒ reset/level to existing base ☐ construct new base
☐ possible new base required ☒ stabilize foundation ☒ resquare

Treatment: ☐ core drill ☒ drill and pin ☐ adhesive repair ☐ infill w/Jahn or U.S. Heritage
☐ injection grout ☐ replace bricks ☐ mortar ☐ repoint ☐ other:

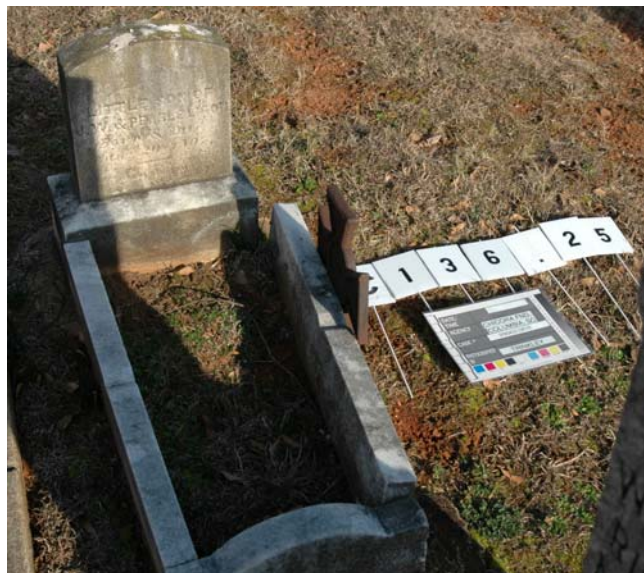
Position: ☒ fallen ☒ unstable ☒ tilted ☒ unattached/loose ☐ missing ☐ shifted

Soiling: ☒ biological ☐ staining ☐ efflorescence ☐ other:

Position: ☐ reset in ground ☒ reset/level to existing base ☐ construct new base
☐ possible new base required ☒ stabilize foundation ☒ resquare

Treatment: ☐ core drill ☒ drill and pin ☐ adhesive repair ☐ infill w/Jahn or U.S. Heritage
☐ injection grout ☐ replace bricks ☐ mortar ☐ repoint ☐ other:

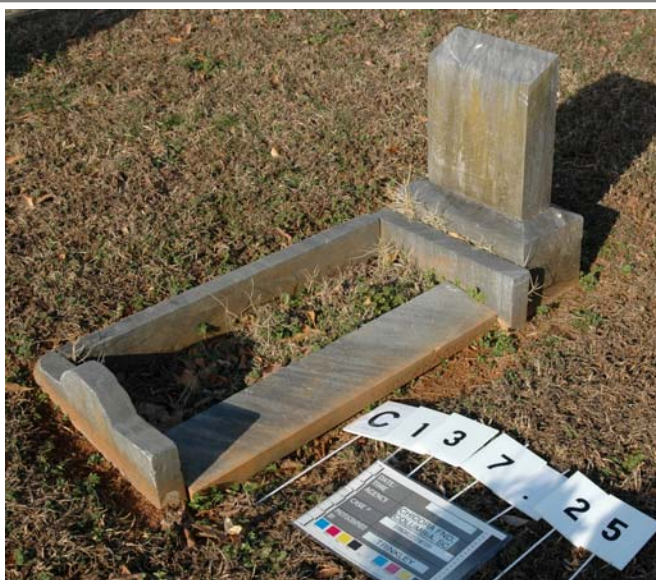
Position: ☐ fallen ☒ unstable ☒ tilted ☐ unattached/loose ☐ missing ☐ shifted

Soiling: ☒ biological ☐ staining ☐ efflorescence ☐ other:

Position: ☐ reset in ground ☒ reset/level to existing base ☐ construct new base
☐ possible new base required ☒ stabilize foundation ☐ resquare

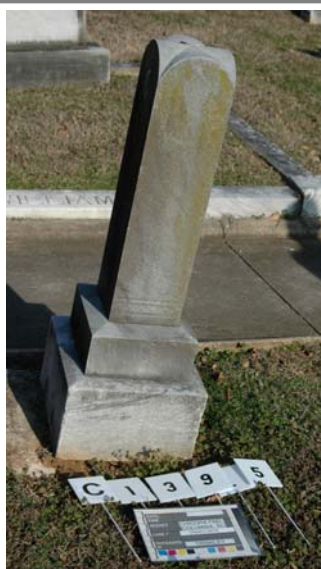
Position: ☐ fallen ☒ unstable ☐ tilted ☒ unattached/loose ☐ missing ☒ shifted

Deterioration: ☐ broken ☐ cracked ☐ losses ☐ flaking/sugaring ☒ ferrous pins
☐ delamination/detachment ☐ missing fragments ☐ other:

Soiling: ☒ biological ☐ staining ☐ efflorescence ☐ other:

Position: ☐ reset in ground ☒ reset/level to existing base ☐ construct new base
☐ possible new base required ☐ stabilize foundation ☐ resquare

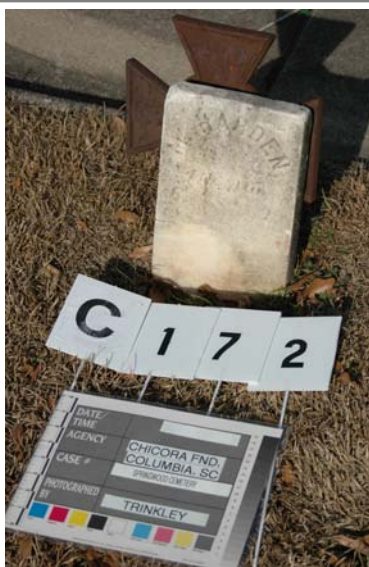
Position: ☒ fallen ☐ unstable ☐ tilted ☐ unattached/loose ☐ missing ☐ shifted

Deterioration: ☒ broken ☐ cracked ☐ losses ☐ flaking/sugaring ☐ ferrous pins
☐ delamination/detachment ☐ missing fragments ☐ other:

Soiling: ☒ biological ☐ staining ☐ efflorescence ☐ other:

Position: ☐ reset in ground ☒ reset/level to existing base ☐ construct new base
☐ possible new base required ☐ stabilize foundation ☐ resquare

Treatment: ☐ core drill ☒ drill and pin ☐ adhesive repair ☒ infill w/Jahn or U.S. Heritage
☐ injection grout ☐ replace bricks ☐ mortar ☐ repoint ☐ other:

Cost: \$400

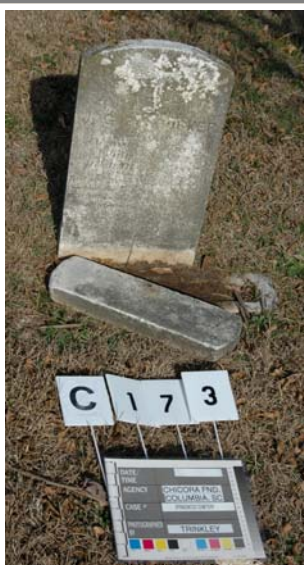
Position: ☒ fallen ☐ unstable ☐ tilted ☒ unattached/loose ☐ missing ☐ shifted

Deterioration: ☒ broken ☐ cracked ☐ losses ☐ flaking/sugaring ☐ ferrous pins
☐ delamination/detachment ☐ missing fragments ☐ other:

Soiling: ☒ biological ☒ staining ☐ efflorescence ☐ other:

Position: ☒ reset in ground ☒ reset/level to existing base ☐ construct new base
☐ possible new base required ☐ stabilize foundation ☐ resquare

Treatment: ☐ core drill ☒ drill and pin ☐ adhesive repair ☒ infill w/Jahn or U.S. Heritage
☐ injection grout ☐ replace bricks ☐ mortar ☐ repoint ☐ other:

Cost: \$700

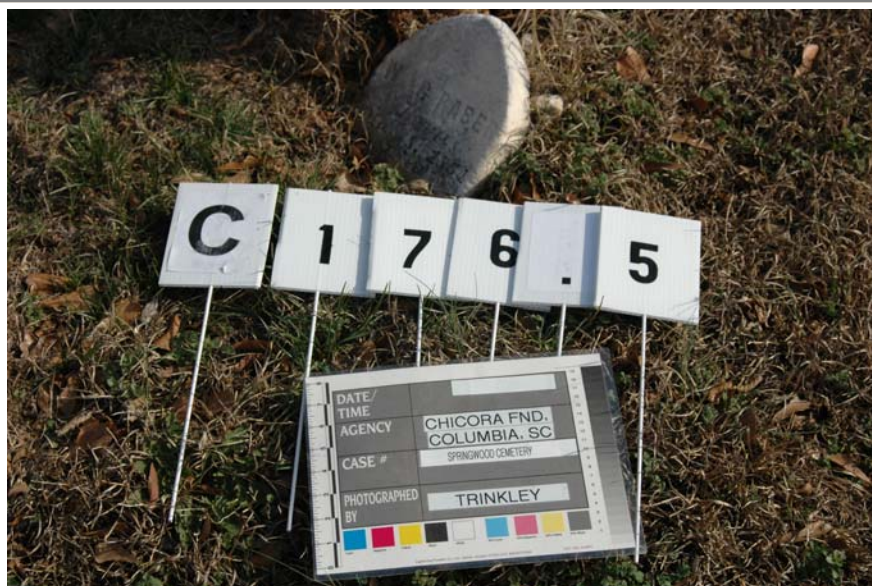
Position: ☒ fallen ☐ unstable ☐ tilted ☐ unattached/loose ☐ missing ☐ shifted

Deterioration: ☒ broken ☐ cracked ☐ losses ☐ flaking/sugaring ☐ ferrous pins
☐ delamination/detachment ☐ missing fragments ☐ other:

Soiling: ☒ biological ☐ staining ☐ efflorescence ☐ other:

Position: ☐ reset in ground ☐ reset/level to existing base ☒ construct new base
☐ possible new base required ☐ stabilize foundation ☐ resquare

Treatment: ☐ core drill ☒ drill and pin ☐ adhesive repair ☒ infill w/Jahn or U.S. Heritage
☐ injection grout ☐ replace bricks ☐ mortar ☐ repoint ☐ other:

Cost: \$650

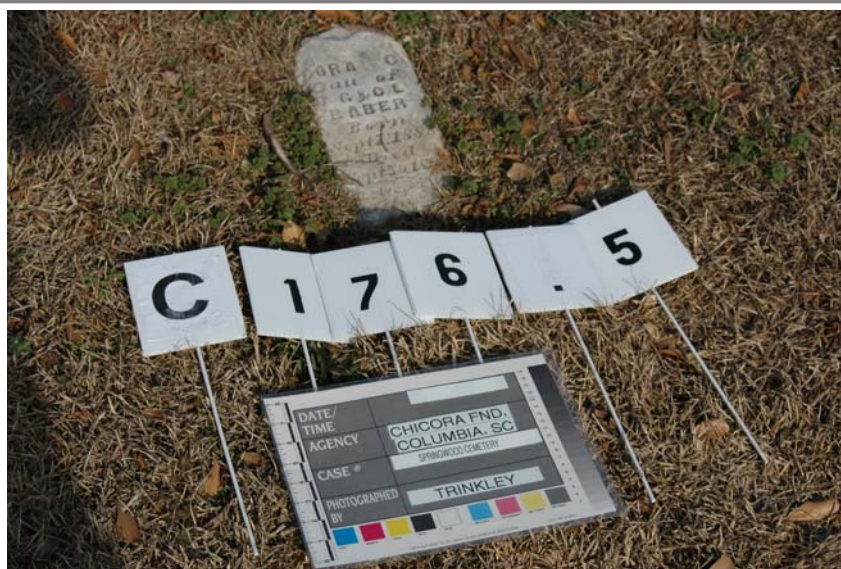
Position: ☒ fallen ☐ unstable ☐ tilted ☐ unattached/loose ☐ missing ☐ shifted

Deterioration: ☒ broken ☐ cracked ☐ losses ☐ flaking/sugaring ☐ ferrous pins
☐ delamination/detachment ☐ missing fragments ☐ other:

Soiling: ☒ biological ☐ staining ☐ efflorescence ☐ other:

Position: ☐ reset in ground ☐ reset/level to existing base ☒ construct new base
☐ possible new base required ☐ stabilize foundation ☐ resquare

Treatment: ☐ core drill ☒ drill and pin ☐ adhesive repair ☒ infill w/Jahn or U.S. Heritage
☐ injection grout ☐ replace bricks ☐ mortar ☐ repoint ☐ other:

Cost: \$650

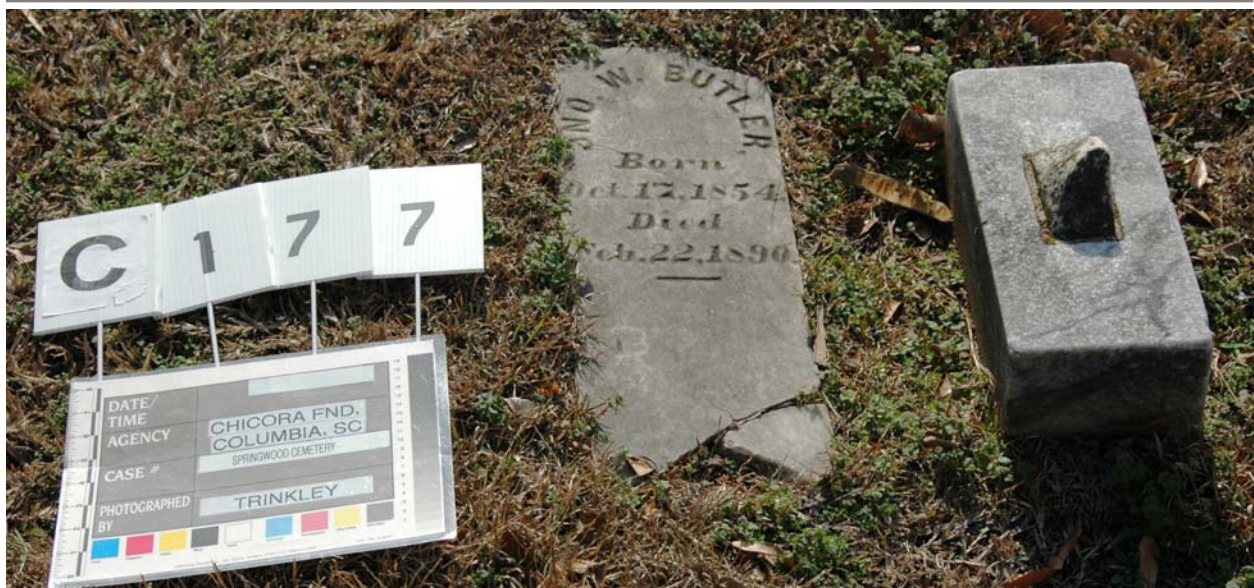
Position: ☒ fallen ☐ unstable ☐ tilted ☐ unattached/loose ☐ missing ☐ shifted

Deterioration: ☒ broken ☒ cracked ☐ losses ☐ flaking/sugaring ☐ ferrous pins
☐ delamination/detachment ☐ missing fragments ☐ other:

Soiling: ☒ biological ☐ staining ☐ efflorescence ☐ other:

Position: ☐ reset in ground ☒ reset/level to existing base ☐ construct new base
☐ possible new base required ☐ stabilize foundation ☐ resquare

Treatment: ☐ core drill ☒ drill and pin ☒ adhesive repair ☒ infill w/Jahn or U.S. Heritage
☐ injection grout ☐ replace bricks ☐ mortar ☐ repoint ☐ other:

Cost: \$600

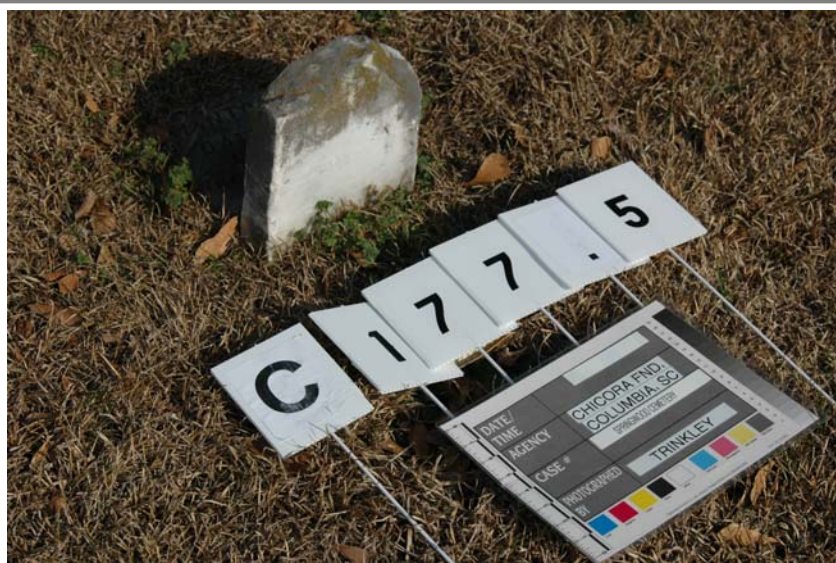
Deterioration: ☒ broken ☐ cracked ☐ losses ☐ flaking/sugaring ☐ ferrous pins
☐ delamination/detachment ☐ missing fragments ☐ other:

Soiling: ☒ biological ☐ staining ☐ efflorescence ☐ other:

Position: ☐ reset in ground ☐ reset/level to existing base ☒ construct new base
☐ possible new base required ☐ stabilize foundation ☐ resquare

Treatment: ☐ core drill ☒ drill and pin ☐ adhesive repair ☒ infill w/Jahn or U.S. Heritage
☐ injection grout ☐ replace bricks ☐ mortar ☐ repoint ☐ other:

Cost: \$650

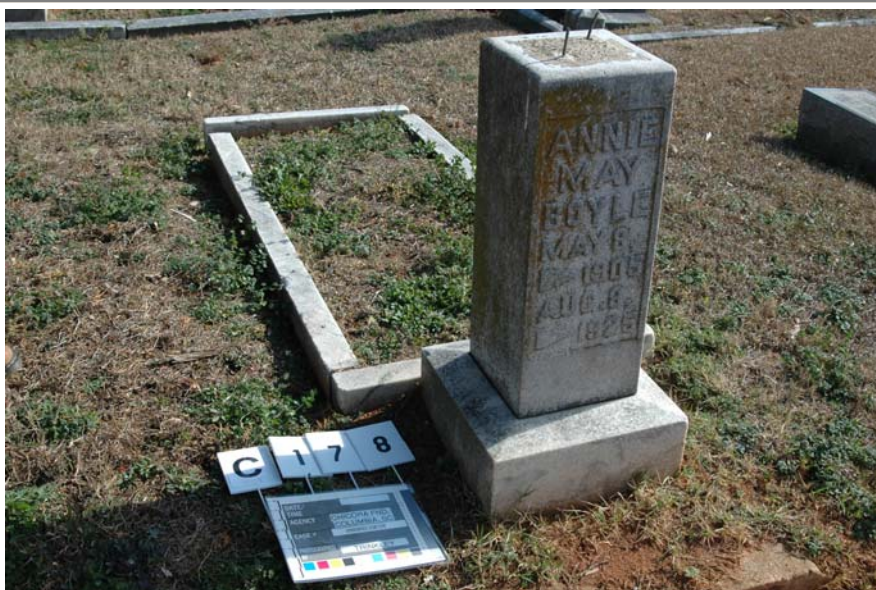
Deterioration: ☐ broken ☐ cracked ☒ losses ☐ flaking/sugaring ☐ ferrous pins
☐ delamination/detachment ☒ missing fragments ☐ other:

Soiling: ☒ biological ☐ staining ☐ efflorescence ☐ other:

Failed Treatments: ☒ drill/grind ☒ hand tools ☐ solvents ☐ other:

Treatment: ☒ core drill ☐ drill and pin ☐ adhesive repair ☒ infill w/Jahn or U.S. Heritage
☐ injection grout ☐ replace bricks ☐ mortar ☐ repoint ☐ other:

Cost: \$200

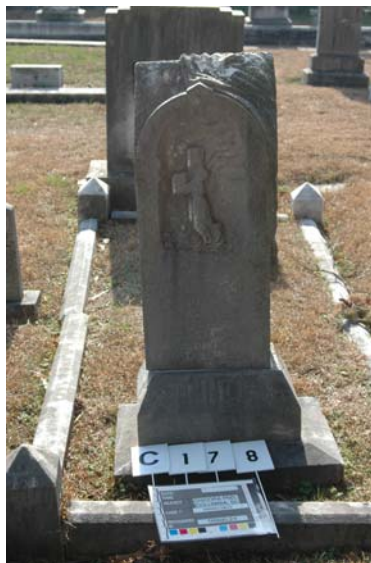
Position: ☐ fallen ☒ unstable ☒ tilted ☒ unattached/loose ☐ missing ☐ shifted

Deterioration: ☐ broken ☐ cracked ☐ losses ☐ flaking/sugaring ☒ ferrous pins
☐ delamination/detachment ☐ missing fragments ☐ other:

Soiling: ☒ biological ☐ staining ☐ efflorescence ☐ other:

Position: ☐ reset in ground ☒ reset/level to existing base ☐ construct new base
☐ possible new base required ☒ stabilize foundation ☐ resquare

Treatment: ☒ core drill ☒ drill and pin ☐ adhesive repair ☐ infill w/Jahn or U.S. Heritage
☐ injection grout ☐ replace bricks ☐ mortar ☐ repoint ☐ other:

Cost: \$700

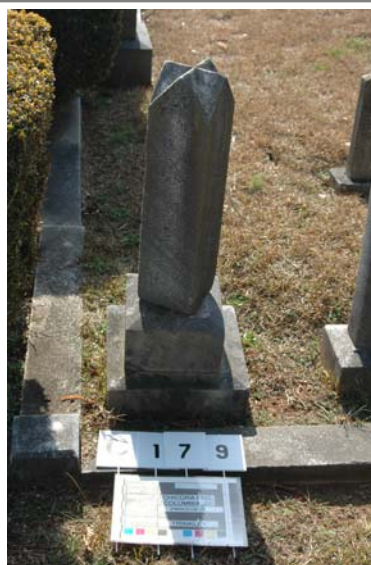
Position: ☐ fallen ☒ unstable ☒ tilted ☒ unattached/loose ☐ missing ☐ shifted

Soiling: ☒ biological ☐ staining ☐ efflorescence ☐ other:

Position: ☐ reset in ground ☒ reset/level to existing base ☐ construct new base
☐ possible new base required ☒ stabilize foundation ☐ resquare

Treatment: ☒ core drill ☒ drill and pin ☐ adhesive repair ☐ infill w/Jahn or U.S. Heritage
☐ injection grout ☐ replace bricks ☐ mortar ☐ repoint ☐ other:

Cost: \$450

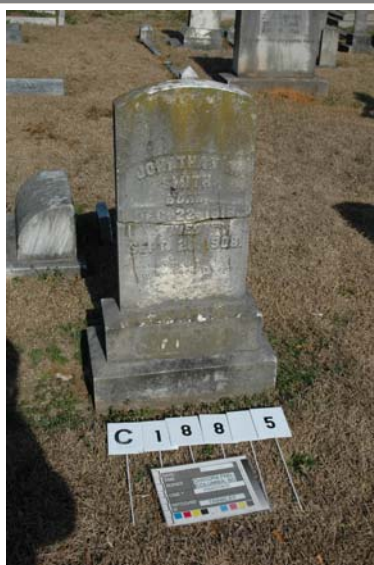
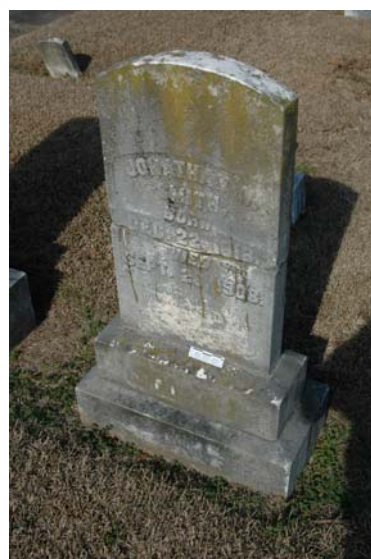
Failed/Old Treatments: ☐ metal ☒ adhesives/coatings ☐ mortar ☒ other: poorly applied

Soiling: ☒ biological ☐ staining ☐ efflorescence ☒ other: adhesive staining/yellowing

Treatment: ☐ core drill ☒ drill and pin ☐ adhesive repair ☐ infill w/Jahn or U.S. Heritage
☐ injection grout ☐ replace bricks ☐ mortar ☐ repoint ☒ other: stable

Cost: n/c

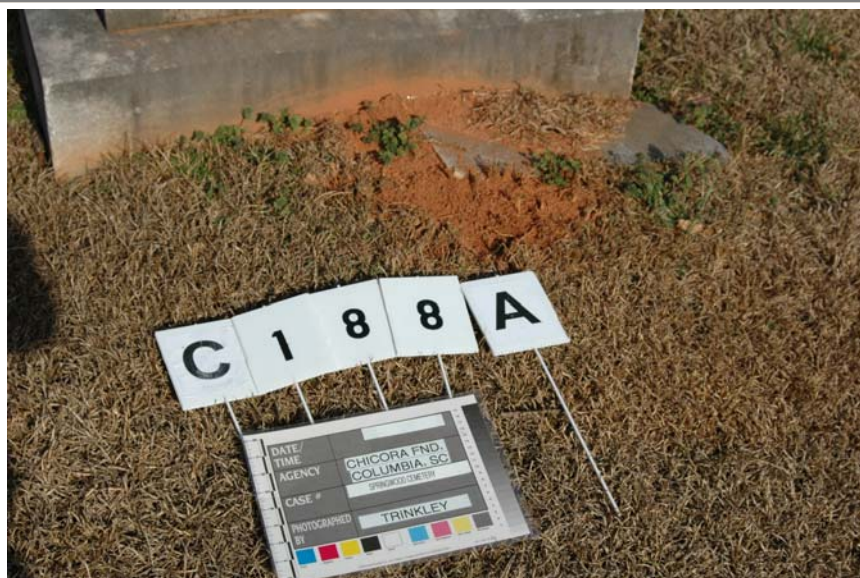
Position: ☒ fallen ☐ unstable ☐ tilted ☐ unattached/loose ☐ missing ☐ shifted

Soiling: ☒ biological ☒ staining ☐ efflorescence ☐ other:

Position: ☒ reset in ground ☐ reset/level to existing base ☐ construct new base
☐ possible new base required ☐ stabilize foundation ☐ resquare

Treatment: ☐ core drill ☒ drill and pin ☐ adhesive repair ☐ infill w/Jahn or U.S. Heritage
☐ injection grout ☐ replace bricks ☐ mortar ☐ repoint ☐ other:

Cost: \$90

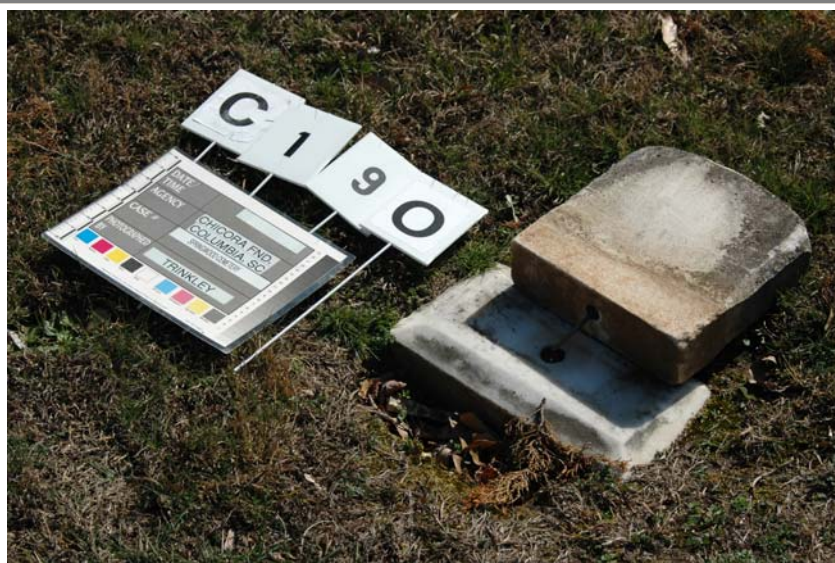
Position: ☒ fallen ☐ unstable ☐ tilted ☒ unattached/loose ☐ missing ☐ shifted

Deterioration: ☐ broken ☐ cracked ☐ losses ☐ flaking/sugaring ☒ ferrous pins
☐ delamination/detachment ☐ missing fragments ☐ other:

Soiling: ☒ biological ☐ staining ☐ efflorescence ☐ other:

Position: ☐ reset in ground ☒ reset/level to existing base ☐ construct new base
☐ possible new base required ☐ stabilize foundation ☐ resquare

Cost: \$450

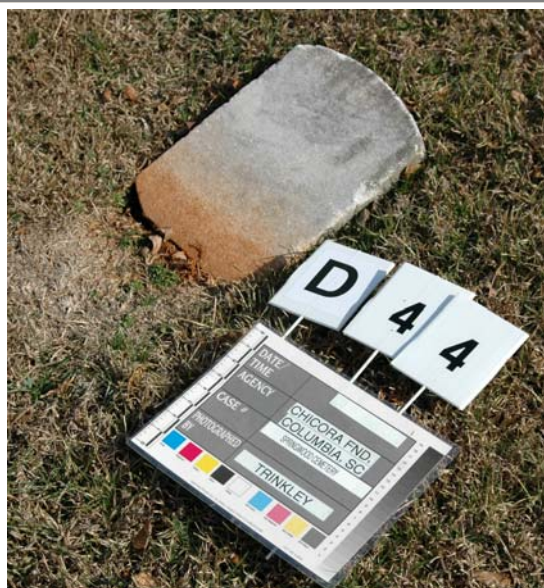
Existing Condition

Position: ☒ fallen ☐ unstable ☐ tilted ☐ unattached/loose ☐ missing ☐ shifted

Deterioration: ☐ broken ☐ cracked ☐ losses ☐ flaking/sugaring ☐ ferrous pins
☐ delamination/detachment ☐ missing fragments ☐ other:

Failed/Old Treatments: ☐ metal ☐ adhesives/coatings ☐ mortar ☐ other:

Soiling: ☐ biological ☐ staining ☐ efflorescence ☐ other:

Position: ☐ reset in ground ☒ reset/level to existing base ☐ construct new base
☐ possible new base required ☐ stabilize foundation ☐ resquare

Treatment: ☐ core drill ☒ drill and pin ☐ adhesive repair ☐ infill w/Jahn or U.S. Heritage
☐ injection grout ☐ replace bricks ☐ mortar ☐ repoint ☐ other:

Cost: \$350

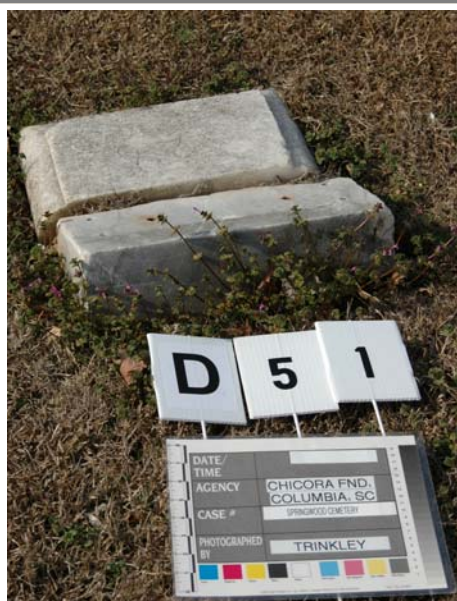
Existing Condition

Position: ☒ fallen ☐ unstable ☐ tilted ☐ unattached/loose ☐ missing ☐ shifted

Deterioration: ☒ broken ☐ cracked ☐ losses ☐ flaking/sugaring ☐ ferrous pins
☐ delamination/detachment ☐ missing fragments ☒ other: tab only

Failed/Old Treatments: ☐ metal ☐ adhesives/coatings ☐ mortar ☐ other:

Soiling: ☐ biological ☐ staining ☐ efflorescence ☐ other:

Position: ☐ reset in ground ☒ reset/level to existing base ☐ construct new base
☐ possible new base required ☐ stabilize foundation ☐ resquare

Treatment: ☐ core drill ☒ drill and pin ☐ adhesive repair ☒ infill w/Jahn or U.S. Heritage
☐ injection grout ☐ replace bricks ☐ mortar ☐ repoint ☐ other:

Cost: \$550

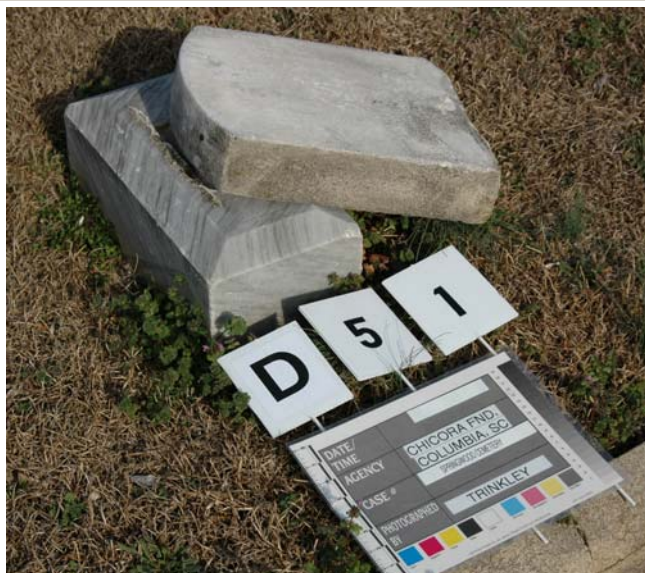
Existing Condition

Position: ☐ fallen ☒ unstable ☒ tilted ☒ unattached/loose ☐ missing ☒ shifted

Deterioration: ☐ broken ☐ cracked ☐ losses ☒ flaking/sugaring ☐ ferrous pins
☐ delamination/detachment ☐ missing fragments ☐ other:

Soiling: ☒ biological ☐ staining ☐ efflorescence ☐ other:

Position: ☐ reset in ground ☒ reset/level to existing base ☐ construct new base
☐ possible new base required ☒ stabilize foundation ☐ resquare

Treatment: ☐ core drill ☒ drill and pin ☐ adhesive repair ☐ infill w/Jahn or U.S. Heritage
☐ injection grout ☐ replace bricks ☐ mortar ☐ repoint ☐ other:

Cost: \$600

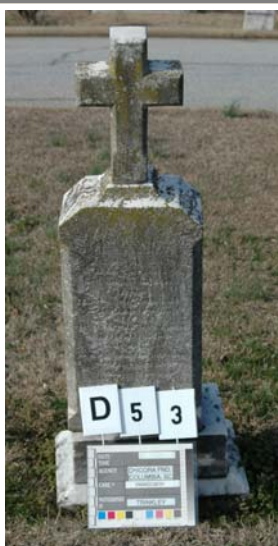
Existing Condition

Position: ☐ fallen ☒ unstable ☒ tilted ☒ unattached/loose ☐ missing ☐ shifted

Soiling: ☒ biological ☐ staining ☐ efflorescence ☐ other:

Position: ☐ reset in ground ☒ reset/level to existing base ☐ construct new base
☐ possible new base required ☒ stabilize foundation ☐ resquare

Treatment: ☐ core drill ☒ drill and pin ☐ adhesive repair ☐ infill w/Jahn or U.S. Heritage
☐ injection grout ☐ replace bricks ☐ mortar ☐ repoint ☐ other:

Cost: \$600

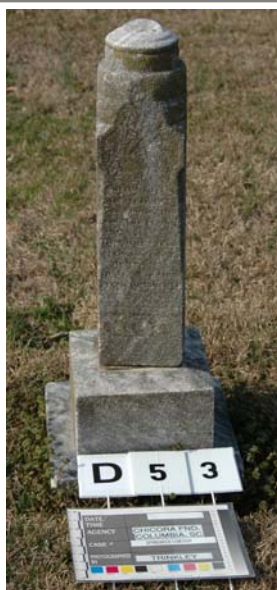
Existing Condition

Position: ☒ fallen ☐ unstable ☐ tilted ☐ unattached/loose ☐ missing ☐ shifted

Position: ☐ reset in ground ☒ reset/level to existing base ☐ construct new base
☐ possible new base required ☐ stabilize foundation ☐ resquare

Treatment: ☐ core drill ☐ drill and pin ☐ adhesive repair ☐ infill w/Jahn or U.S. Heritage
☐ injection grout ☐ replace bricks ☐ mortar ☐ repoint ☒ other: use setting compound

Cost: \$250

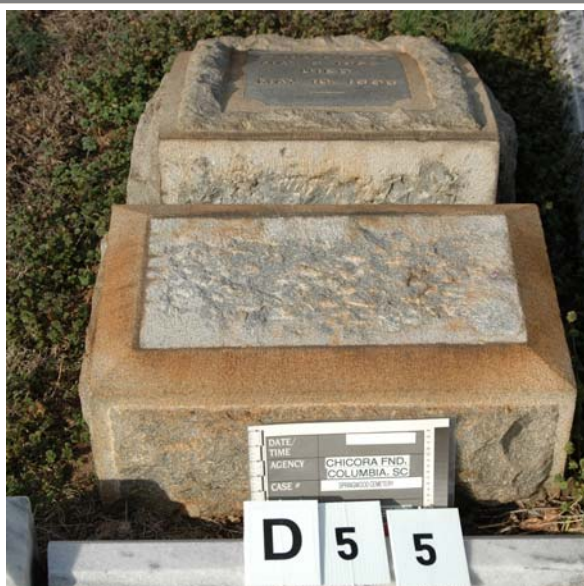
Existing Condition

Position: ☒ fallen ☐ unstable ☐ tilted ☐ unattached/loose ☐ missing ☐ shifted

Soiling: ☒ biological ☐ staining ☐ efflorescence ☐ other:

Position: ☐ reset in ground ☒ reset/level to existing base ☐ construct new base
☐ possible new base required ☒ stabilize foundation ☐ resquare

Treatment: ☐ core drill ☒ drill and pin ☐ adhesive repair ☐ infill w/Jahn or U.S. Heritage
☐ injection grout ☐ replace bricks ☐ mortar ☐ repoint ☐ other:

Cost: \$200

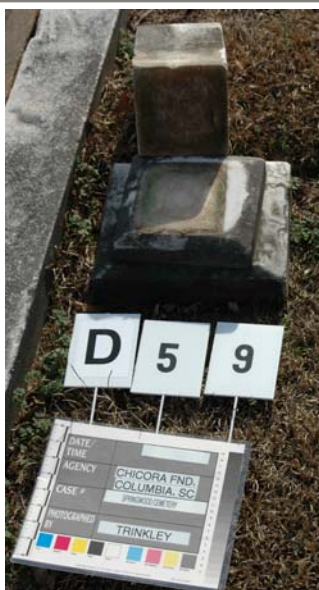
Existing Condition

Position: ☒ fallen ☐ unstable ☐ tilted ☐ unattached/loose ☐ missing ☐ shifted

Soiling: ☒ biological ☐ staining ☐ efflorescence ☐ other:

Position: ☐ reset in ground ☒ reset/level to existing base ☐ construct new base
☐ possible new base required ☐ stabilize foundation ☐ resquare

Treatment: ☐ core drill ☒ drill and pin ☐ adhesive repair ☐ infill w/Jahn or U.S. Heritage
☐ injection grout ☐ replace bricks ☐ mortar ☐ repoint ☐ other:

Cost: \$350

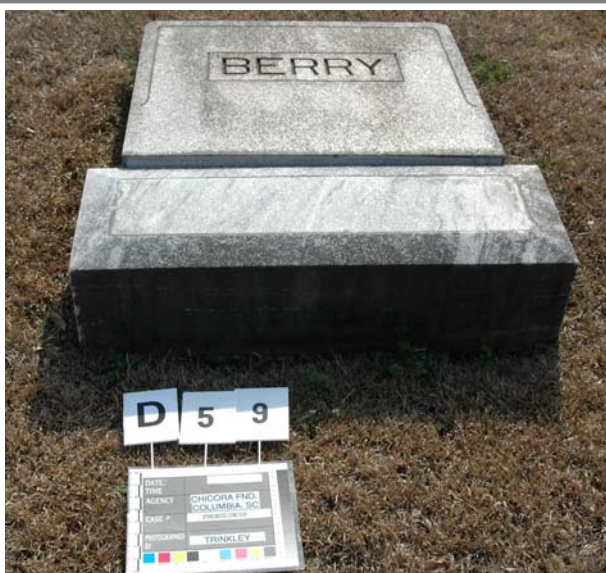
Existing Condition

Position: ☒ fallen ☒ unstable ☒ tilted ☒ unattached/loose ☐ missing ☐ shifted

Soiling: ☒ biological ☐ staining ☐ efflorescence ☐ other:

Position: ☐ reset in ground ☒ reset/level to existing base ☐ construct new base
☐ possible new base required ☒ stabilize foundation ☒ resquare

Treatment: ☐ core drill ☒ drill and pin ☐ adhesive repair ☐ infill w/Jahn or U.S. Heritage
☐ injection grout ☐ replace bricks ☐ mortar ☐ repoint ☐ other:

Cost: \$850

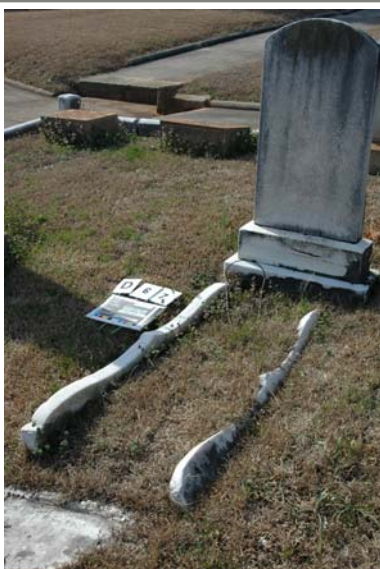
Existing Condition

Position: ☐ fallen ☒ unstable ☐ tilted ☒ unattached/loose ☐ missing ☐ shifted

Soiling: ☒ biological ☐ staining ☐ efflorescence ☐ other:

Position: ☐ reset in ground ☒ reset/level to existing base ☐ construct new base
☐ possible new base required ☒ stabilize foundation ☐ resquare

Treatment: ☐ core drill ☐ drill and pin ☐ adhesive repair ☐ infill w/Jahn or U.S. Heritage
☐ injection grout ☐ replace bricks ☒ mortar ☐ repoint ☐ other:

Cost: \$250

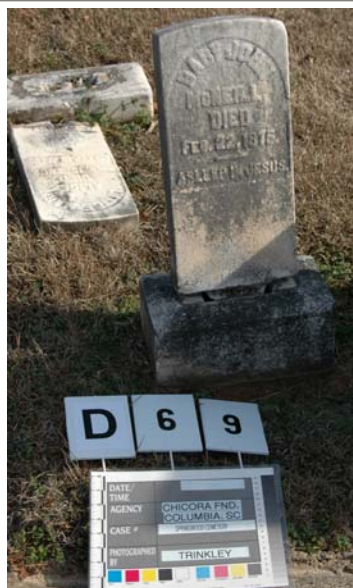
Existing Condition

Position: ☒ fallen ☐ unstable ☐ tilted ☐ unattached/loose ☐ missing ☐ shifted

Deterioration: ☒ broken ☐ cracked ☐ losses ☐ flaking/sugaring ☐ ferrous pins
☐ delamination/detachment ☐ missing fragments ☒ other: tab only; socket damaged

Failed/Old Treatments: ☐ metal ☒ adhesives/coatings ☐ mortar ☐ other:

Soiling: ☒ biological ☐ staining ☐ efflorescence ☐ other:

Position: ☐ reset in ground ☒ reset/level to existing base ☐ construct new base
☐ possible new base required ☐ stabilize foundation ☐ resquare

Treatment: ☐ core drill ☒ drill and pin ☐ adhesive repair ☒ infill w/Jahn or U.S. Heritage
☐ injection grout ☐ replace bricks ☐ mortar ☐ repoint ☐ other:

Cost: \$600

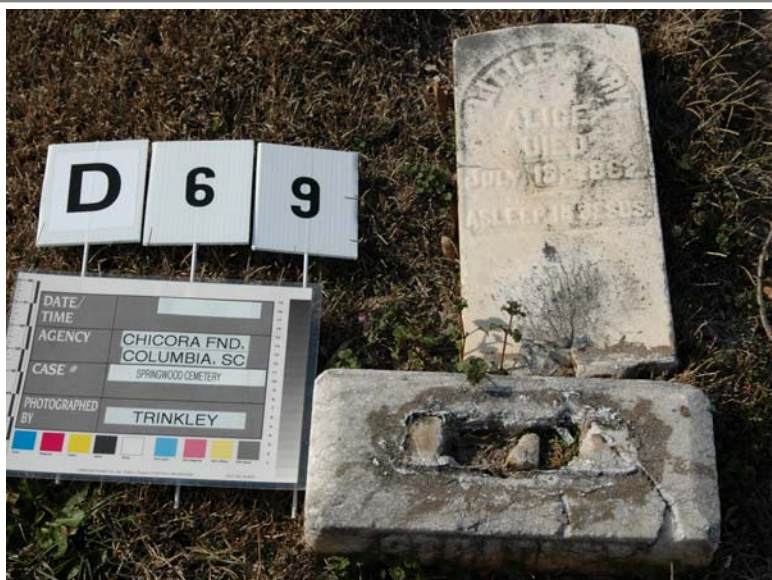
Existing Condition

Position: ☐ fallen ☒ unstable ☒ tilted ☒ unattached/loose ☐ missing ☐ shifted

Deterioration: ☐ broken ☐ cracked ☐ losses ☐ flaking/sugaring ☒ ferrous pins
☐ delamination/detachment ☐ missing fragments ☐ other:

Failed/Old Treatments: ☐ metal ☒ adhesives/coatings ☐ mortar ☒ other: currently stable

Soiling: ☒ biological ☐ staining ☐ efflorescence ☐ other:

Position: ☐ reset in ground ☒ reset/level to existing base ☐ construct new base
☐ possible new base required ☐ stabilize foundation ☐ resquare

Treatment: ☒ core drill ☒ drill and pin ☐ adhesive repair ☐ infill w/Jahn or U.S. Heritage
☐ injection grout ☐ replace bricks ☐ mortar ☐ repoint ☐ other:

Cost: \$650

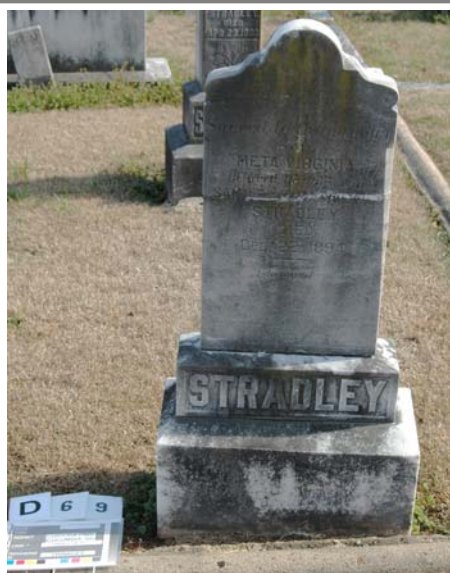
Existing Condition

Position: ☒ fallen ☐ unstable ☐ tilted ☐ unattached/loose ☐ missing ☐ shifted

Cost: \$250

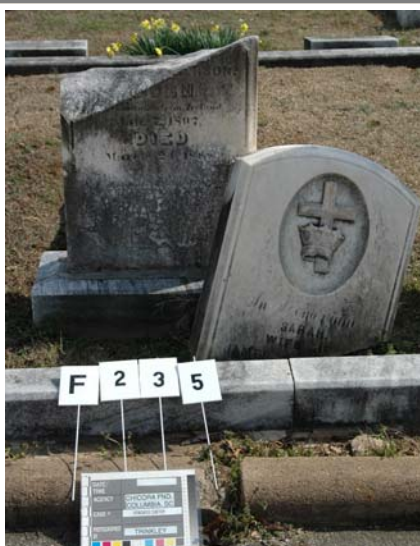
Position: ☐ fallen ☒ unstable ☐ tilted ☒ unattached/loose ☐ missing ☐ shifted

Deterioration: ☒ broken ☐ cracked ☐ losses ☐ flaking/sugaring ☐ ferrous pins
☐ delamination/detachment ☐ missing fragments ☐ other:

Soiling: ☒ biological ☐ staining ☐ efflorescence ☐ other:

Position: ☐ reset in ground ☒ reset/level to existing base ☐ construct new base
☐ possible new base required ☐ stabilize foundation ☐ resquare

Treatment: ☐ core drill ☒ drill and pin ☐ adhesive repair ☒ infill w/Jahn or U.S. Heritage
☐ injection grout ☐ replace bricks ☐ mortar ☐ repoint ☐ other:
